CONSTRUCTION STORMWATER GENERAL PERMIT INSPECTION REPORT

State of Washington Department of Ecology

The Electron Hydro LLC Intake project is covered under the State of Washington's Construction Stormwater General Permit (CSWGP). The CSWGP is a National Pollutant Discharge Elimination System (NPDES) and a State Waste Discharge permit for discharge of construction-related stormwater. Carol Serdar had previously been to the site a few years' prior, during the JARPA review for the then proposed construction of the barrier dam and intake structure.

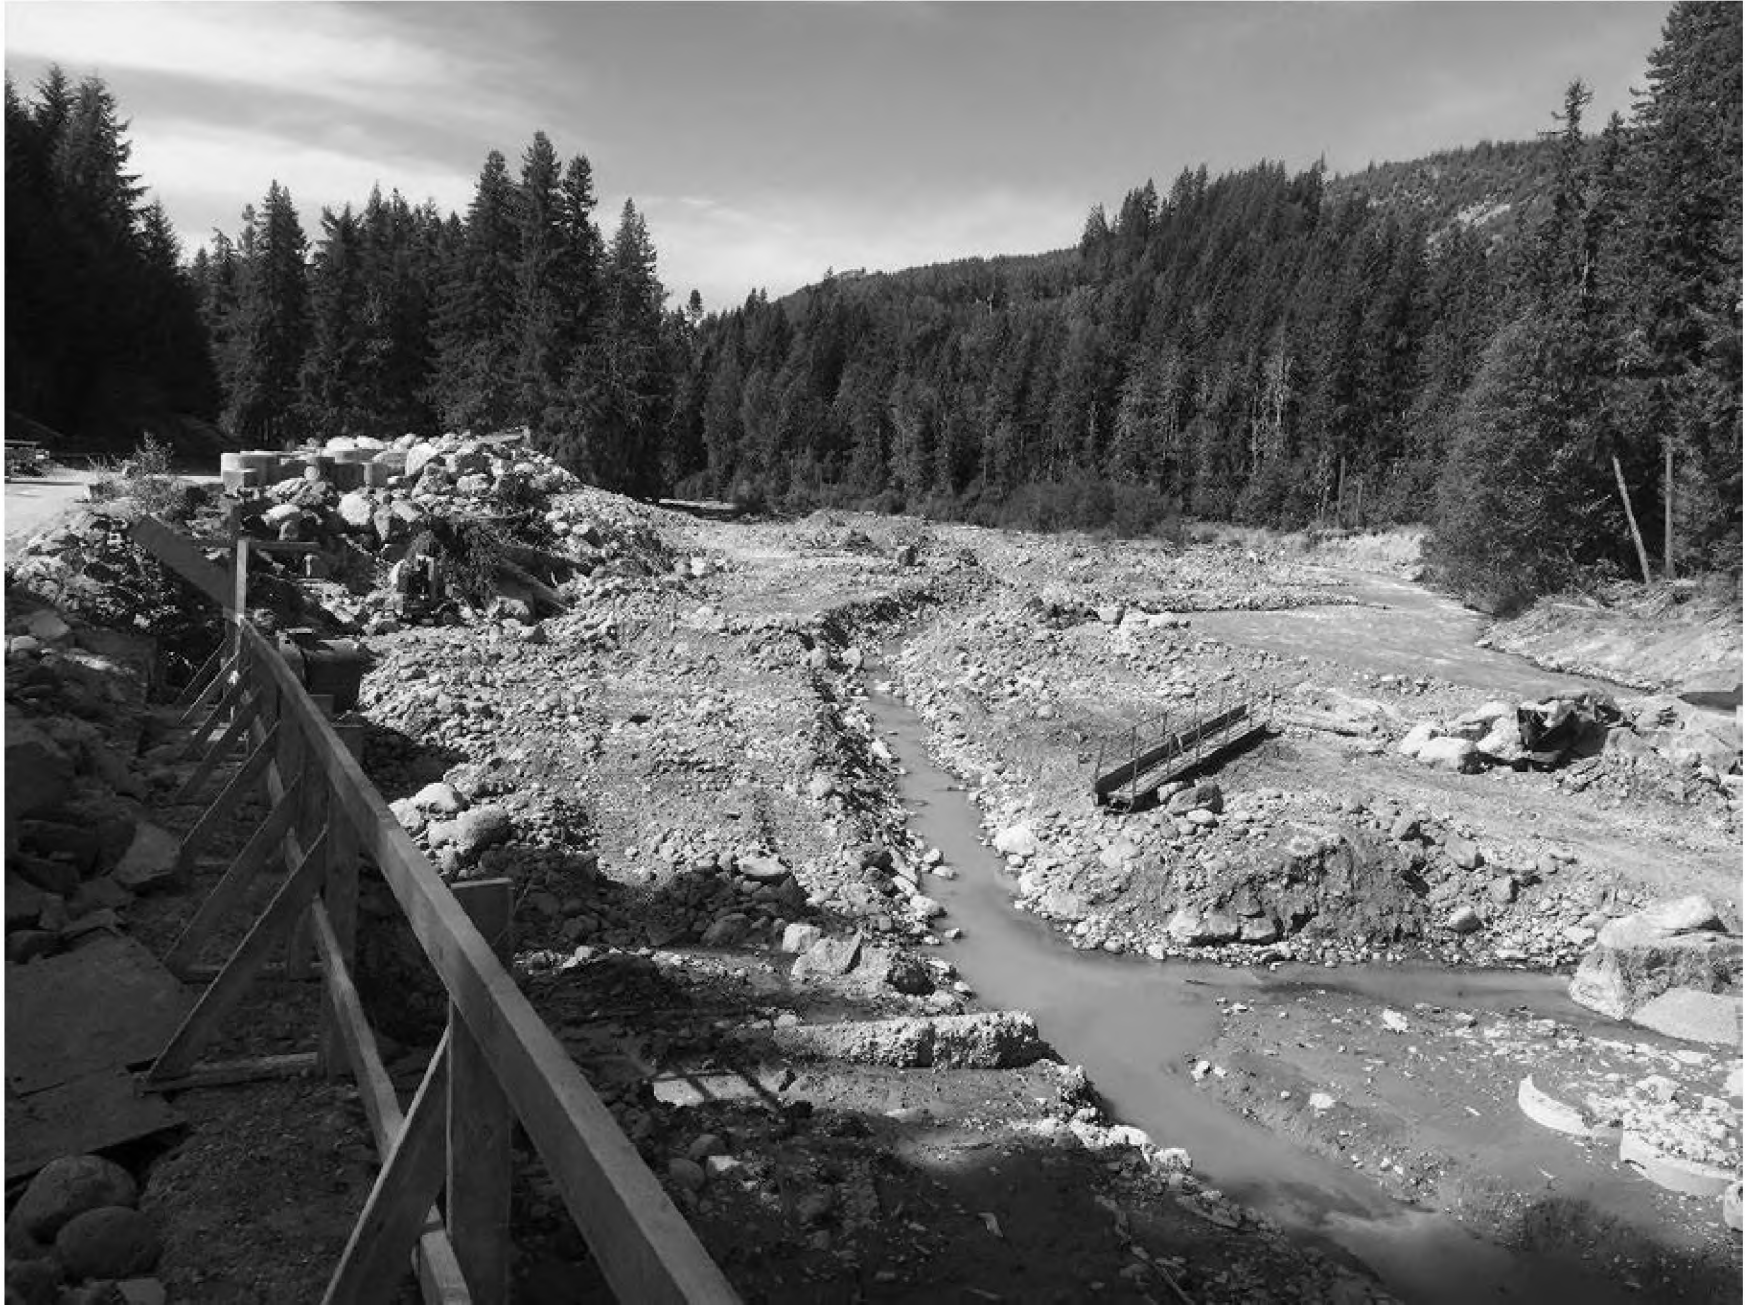
Photo 5

Light pole with generators appeared to not have secondary containment, on closer inspection, the light poles have built in secondary containment. Other generators, including a large one for the pumping of dewatering water in construction zone, do not have secondary containment. Secondary containment is a requirement of CSWGP condition S9.D.9.b. (secondary containment means placing tanks or containers within an impervious structure capable of containing 110% of the volume contained in the largest tank within the containment structure).

Photo Description: No secondary containment for green pump for dewatering the construction zone.

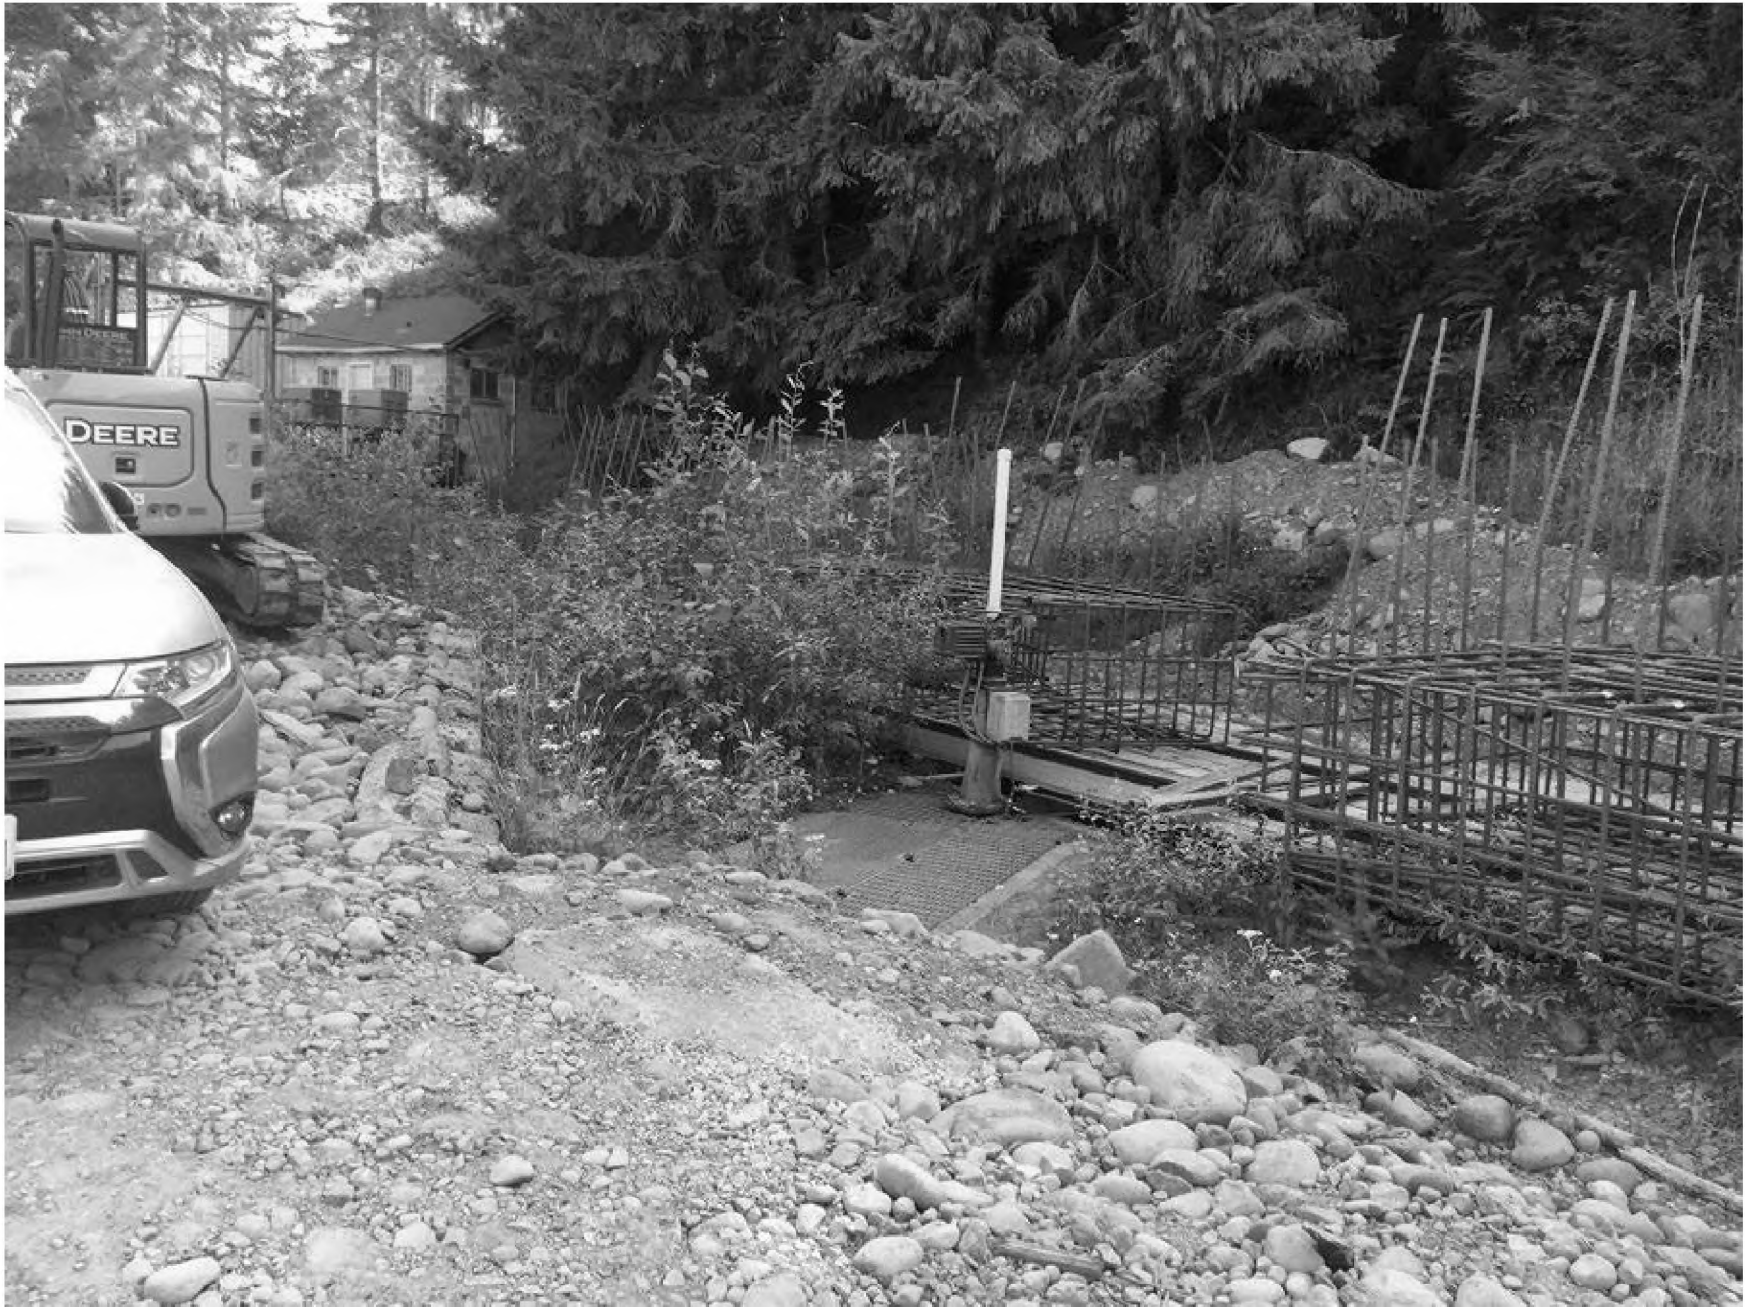
Photo 6

The long, bare/exposed and unworked soil slopes from the road down toward the Ordinary High Water (OHW) of the Puyallup River was discussed and based on the CSWGP must be stabilized within seven days (CSWGP condition S9.D.9.d.); the driving surface of the road consists of fine silt/dirt which likely will cause a significant discharge into waters of the state at the first storm event. Thom agreed the road surface needed to be modified and we discussed BMP options.

Photo Description: Fine silt/dirt and rounded river rock is the haul route surface.

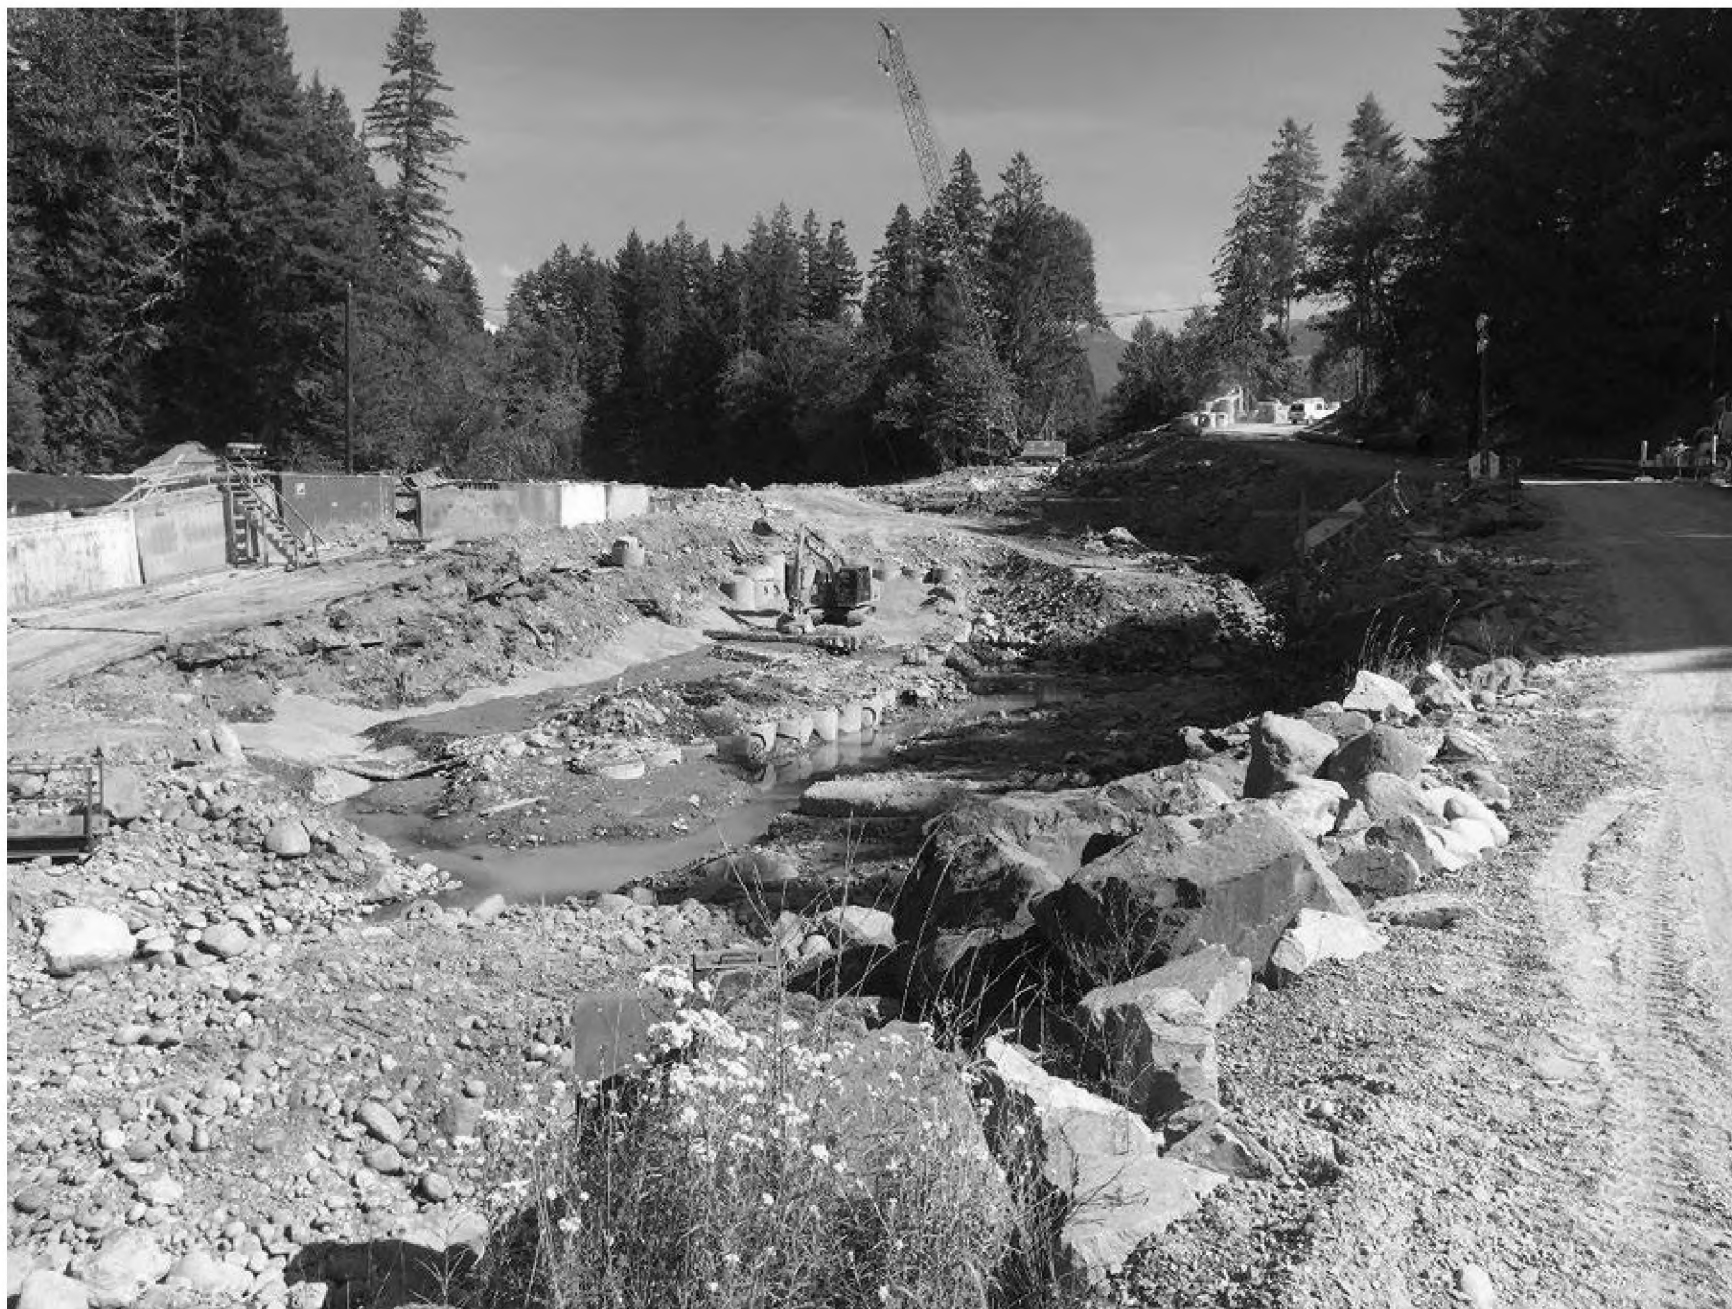
Photo 10

Photo Description: No BMPs along haul road and side slopes; during storm events, this slope will likely deliver additional turbid water to the construction area in the riverbed.

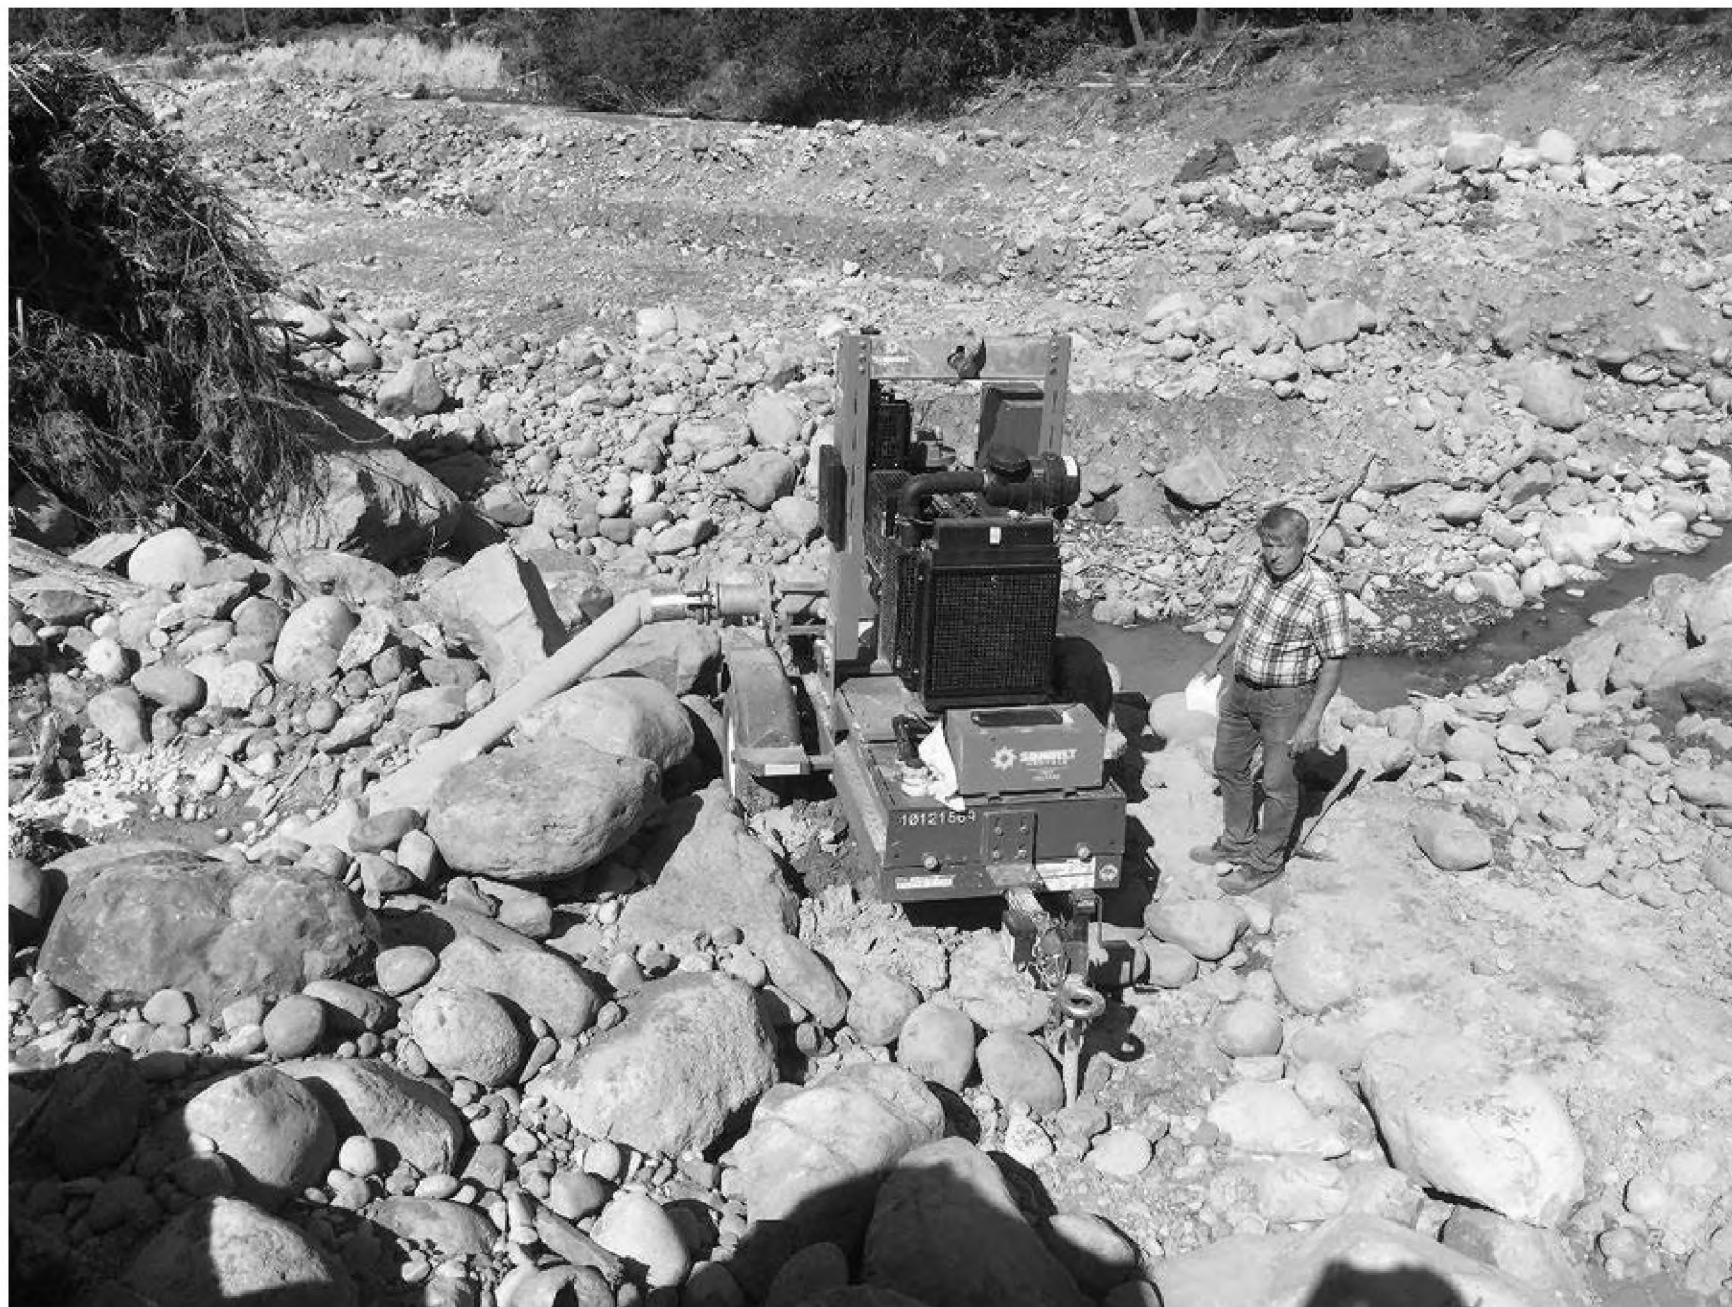
Photo 11

Photo Description: In water construction zone pump for dewatering has no secondary containment for (110% capacity) of the fuel in the generator.

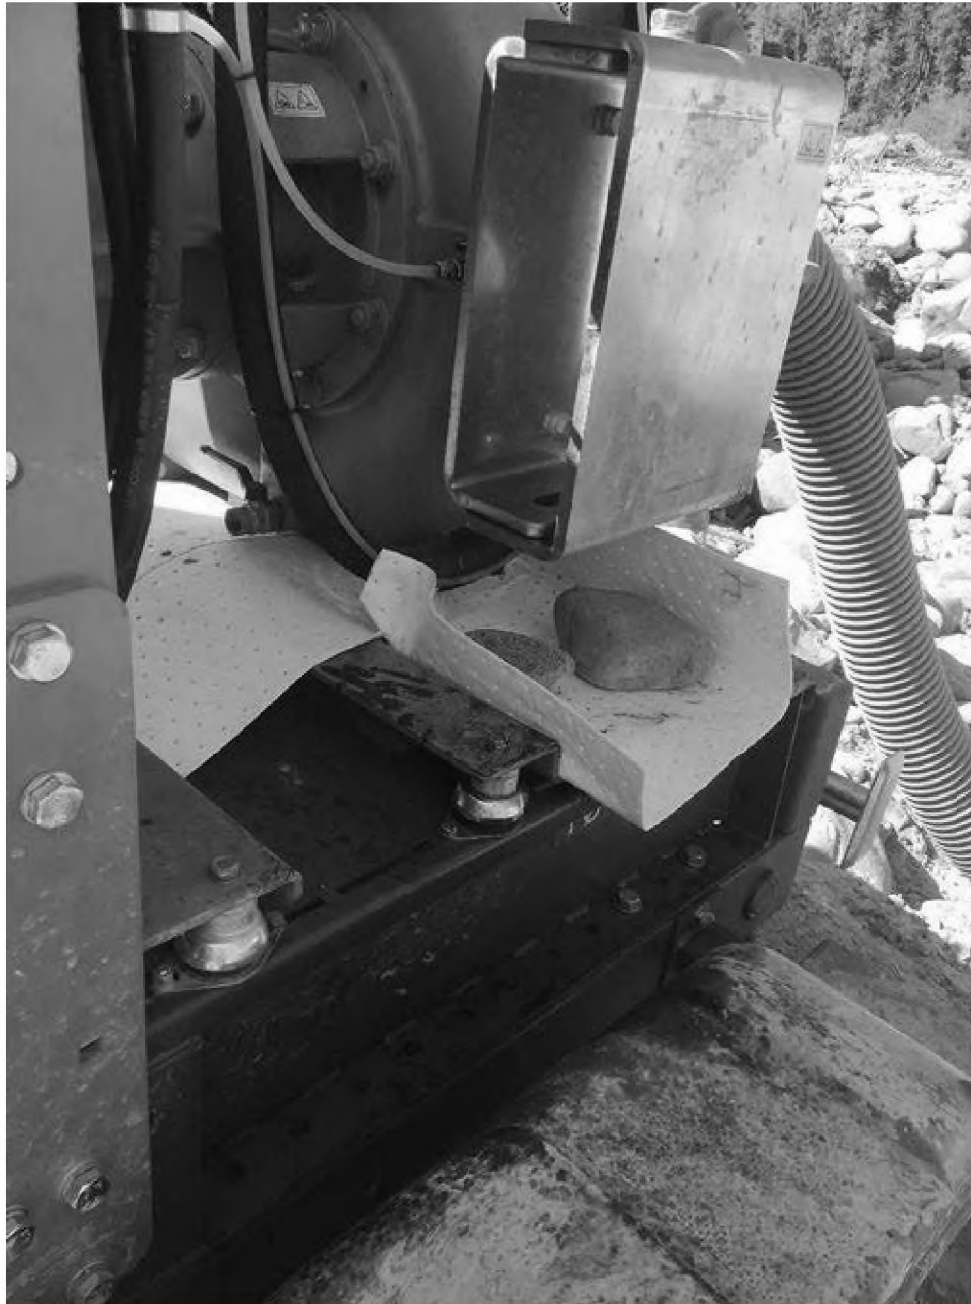
Photo 12

Construction stormwater management was explained: water from upland staging and dewatering water from the construction zone in the riverbed are comingled in the CSWGP stormwater system. This system includes a conveyance ditch near the base of the hillslope, sediment pond containing an outlet structure, which when overflows, drains to the stormwater pond. Water from the stormwater pond is settled out through a series of weirs constructed of straw bales. Discussed that although many sites use straw bales, the usage of straw bales as a BMP were removed from the Stormwater Management Manual of Western Washington (SWMMWW) in 2014. Use of the 2019 SWMMWW is now the requirement of the CSWGP (as of 31 December 2020 – CSWGP revision in process now).

Photo Description: Generator for pumping water from the construction zone; water is pumped to CSWGP stormwater management BMPs (conveyance ditch, sediment pond, then stormwater pond); river water is comingled with construction water.

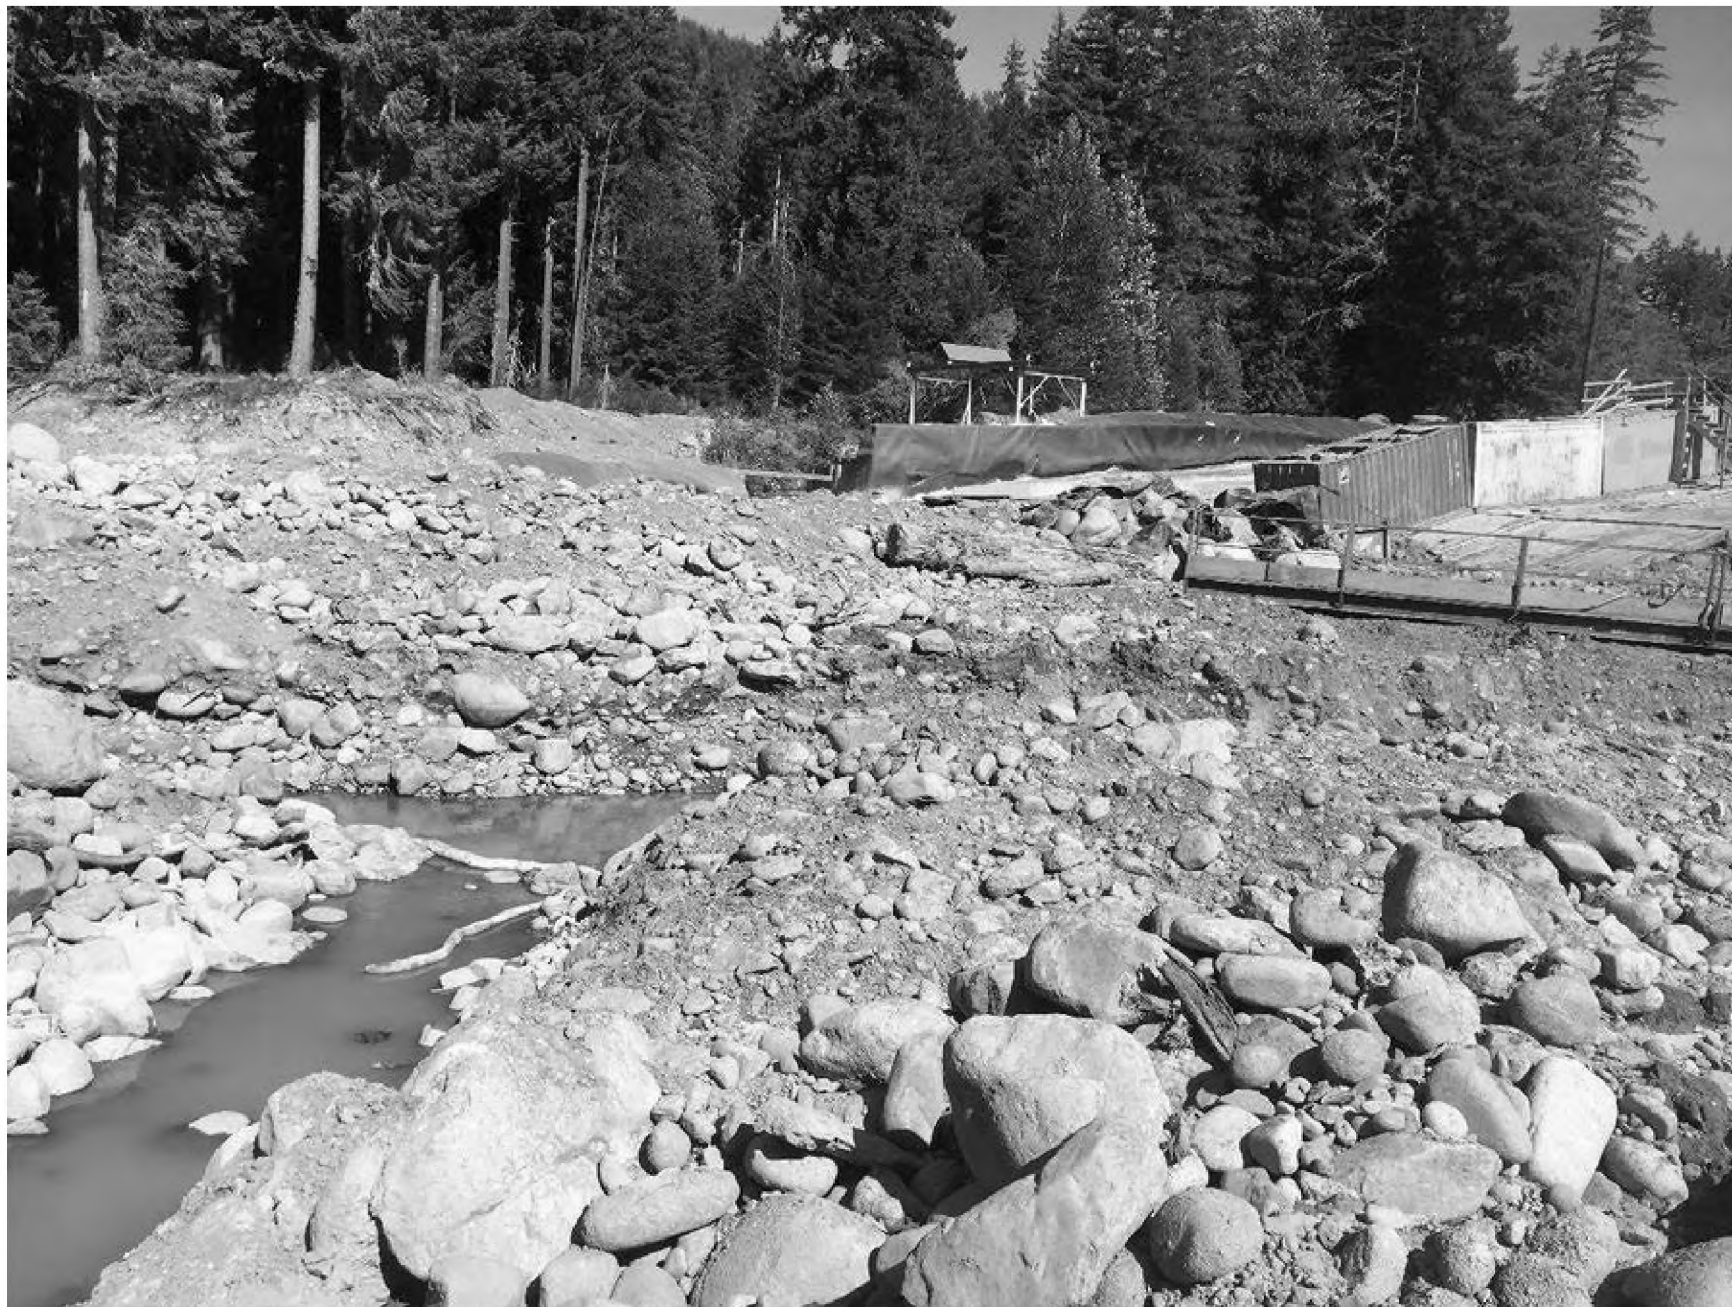
Photo 13

Photo Description: Oil booms are not functional when not secured as intended.

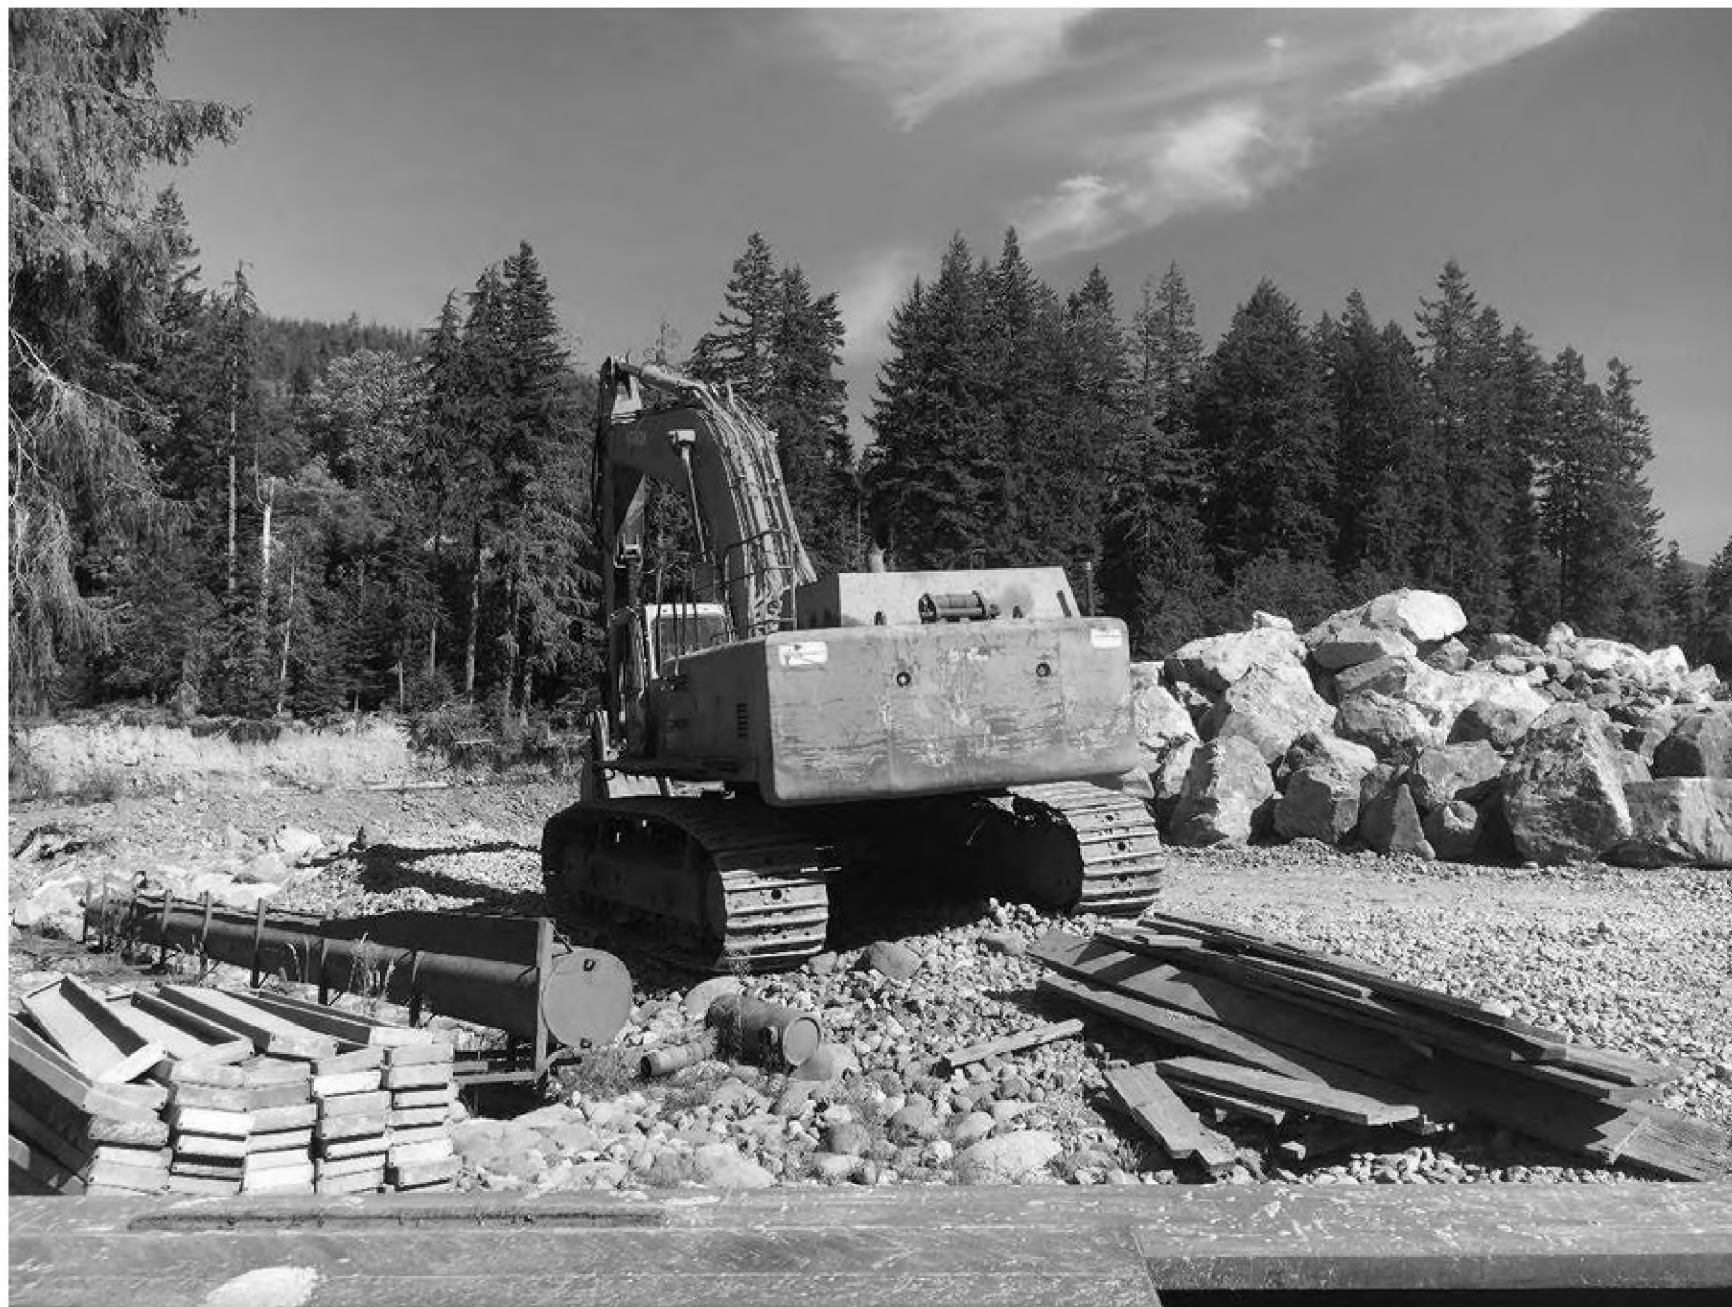
Photo 17

Photo Description: Equipment is checked for leaks at beginning and end of work day.

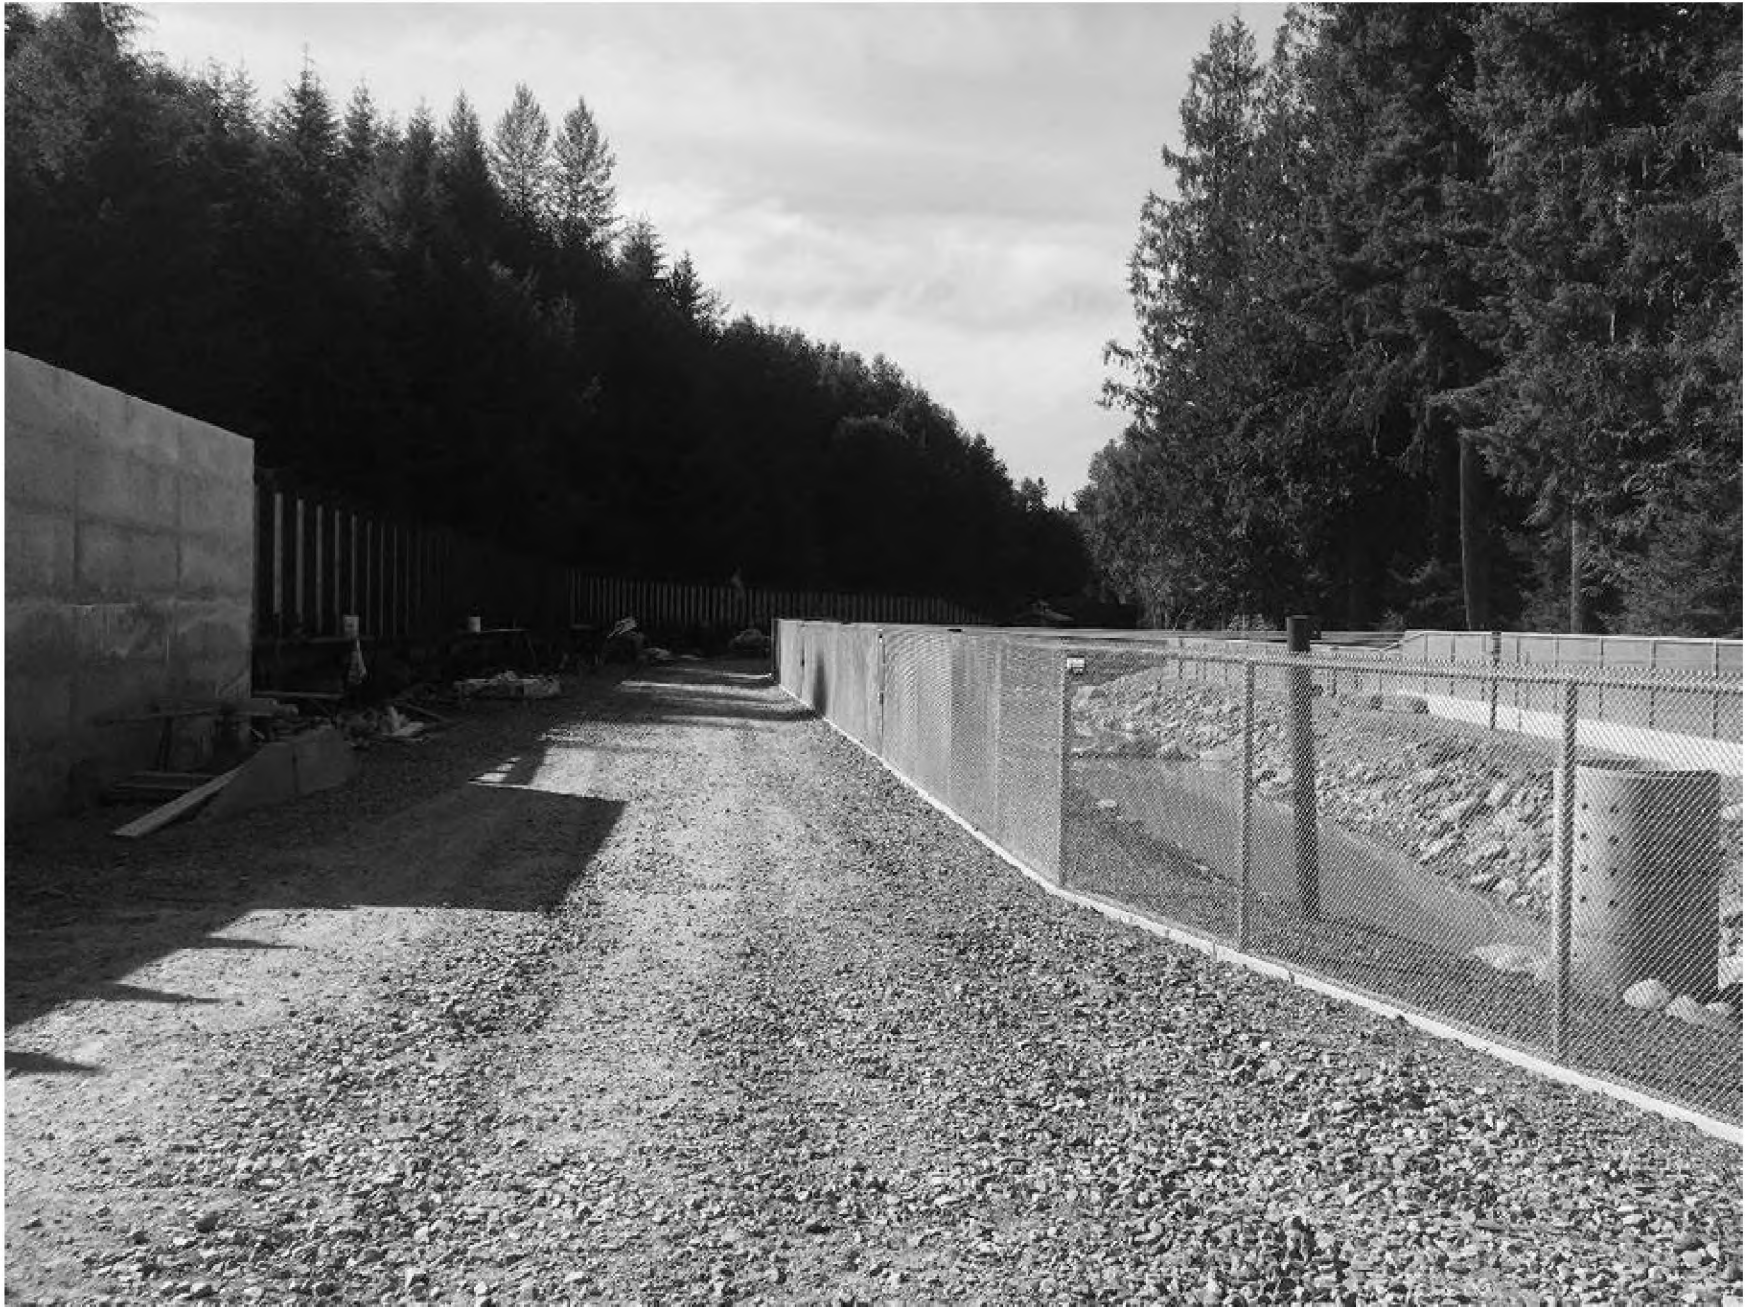
Photo 18

Photo Description: Stormwater pond (potentially a future acclimation pond for salmonids). Water enters this stormwater pond after traveling along the conveyance ditch, into the sediment pond (Photo 19).

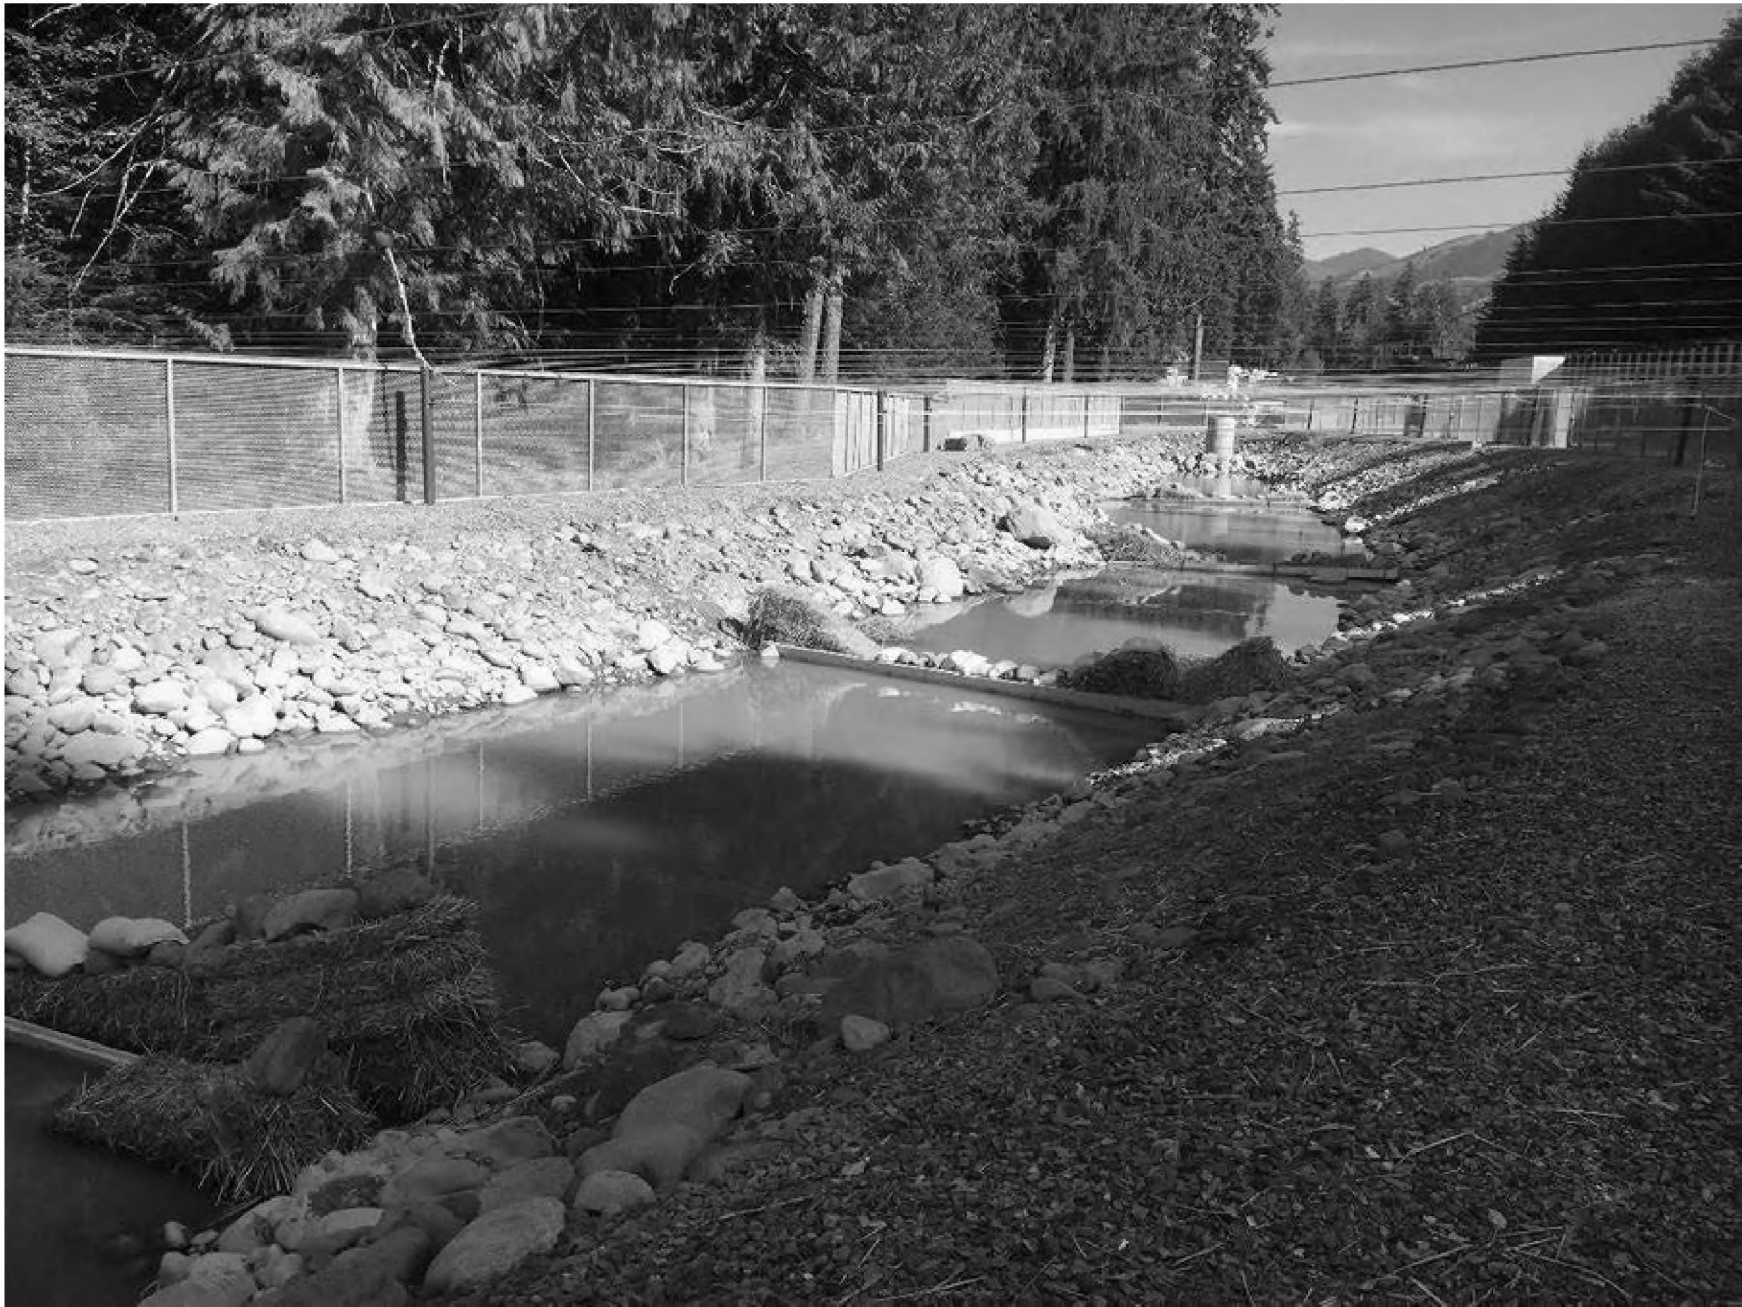
Photo 20

Photo Description: Looking upstream in the Stormwater Pond. Three bays, constructed with straw bales.

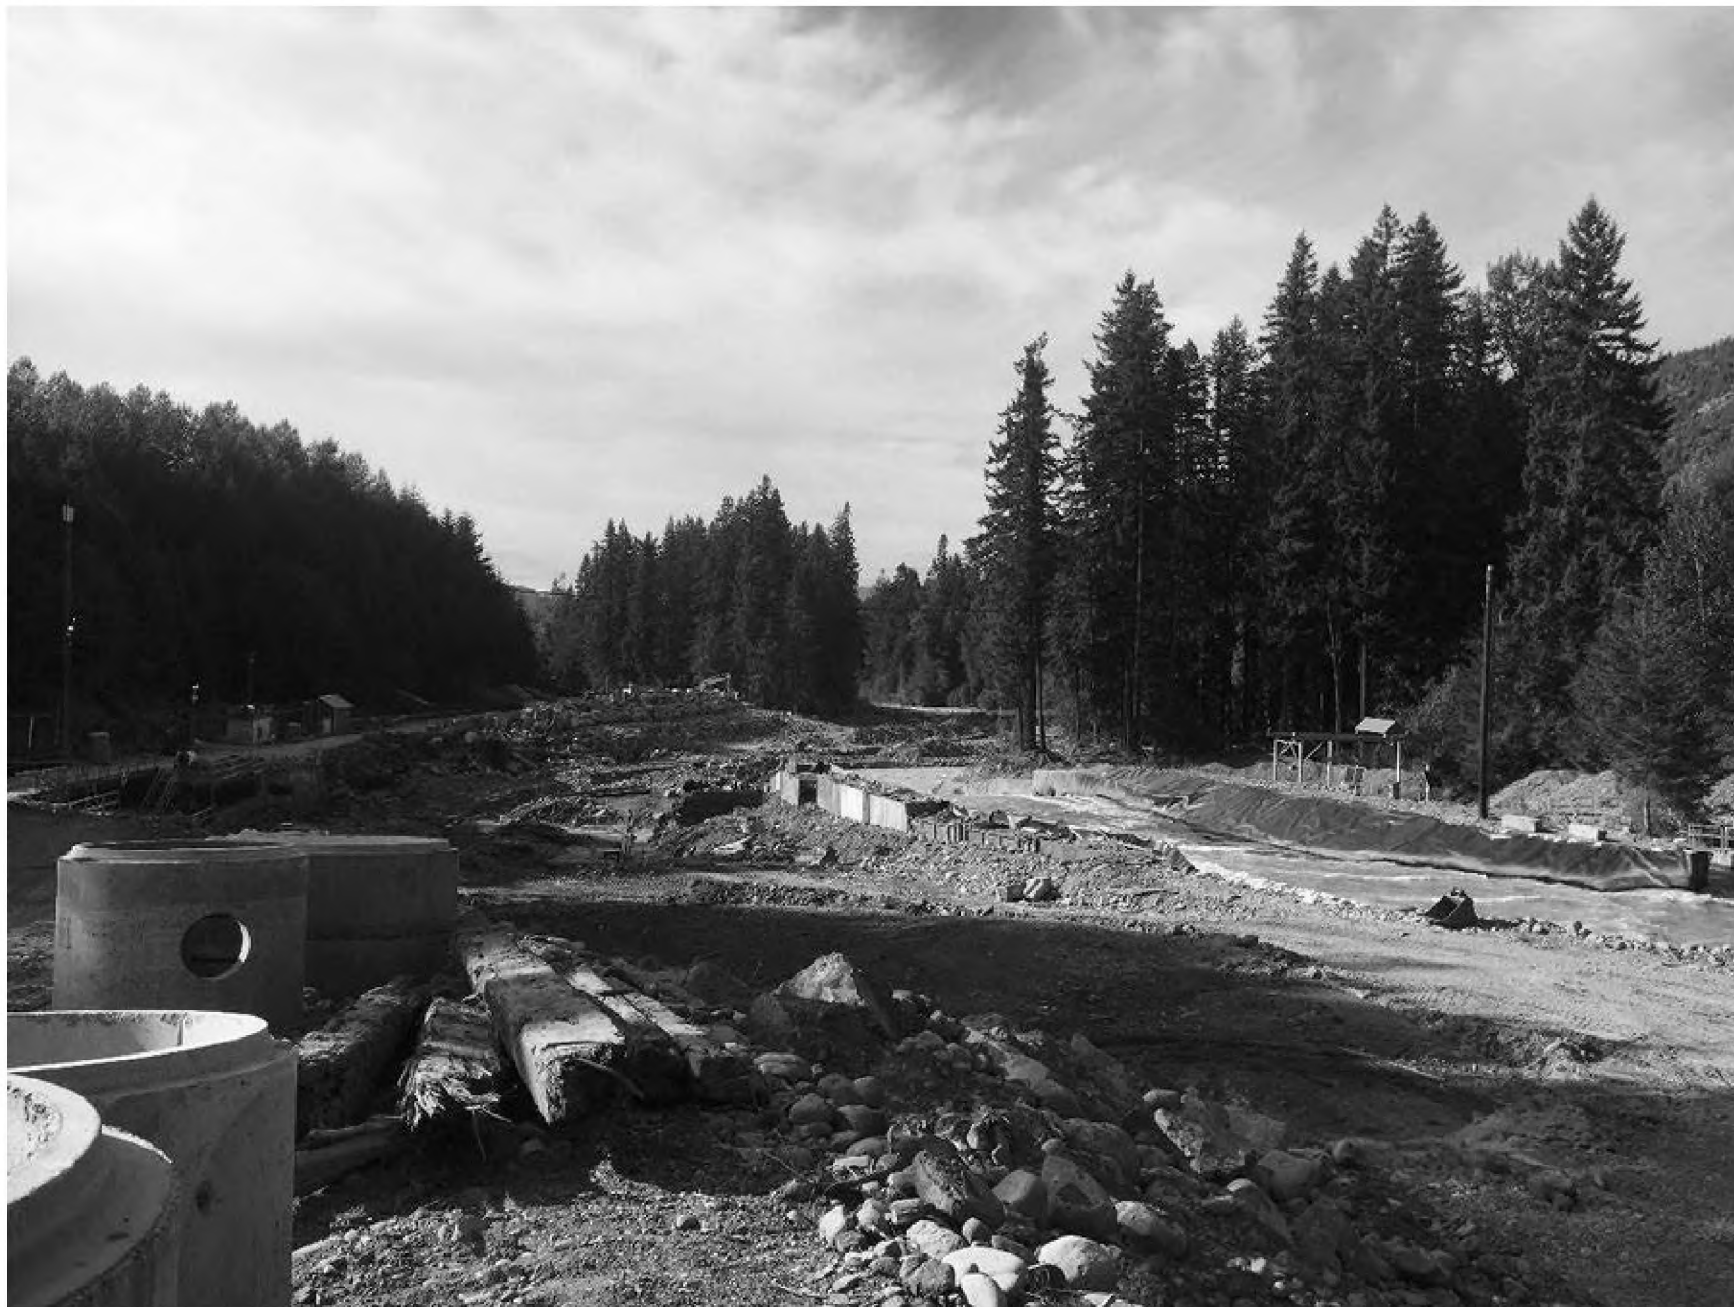
Photo 31

No rubber bits from the sports turf were observed in the area along the big bend in the access/haul road. Thom stated he would have his employees look for and remove any additional black rubber bits from the sports turf and dispose of them properly (garbage bags and brought to an appropriate landfill).

Photo Description: Looking downstream from crane location; this is the area rolls of sports turf was delivered. No black rubber bits were observed on the ground in this location.
